COASTAL RESTORATION SERIES

Freshwater Coastal Prairie Wetland Restoration— Case Study: Sheldon Lake State Park

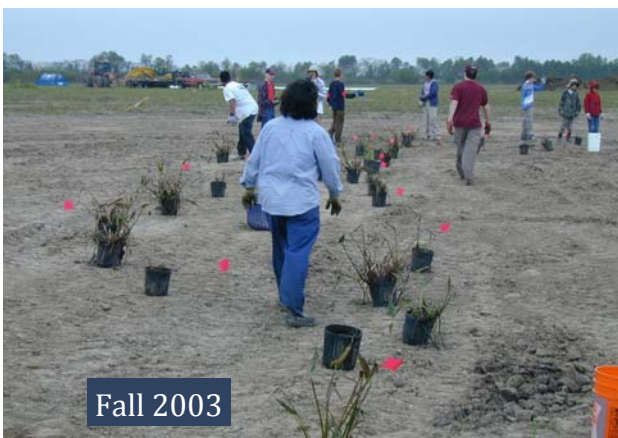
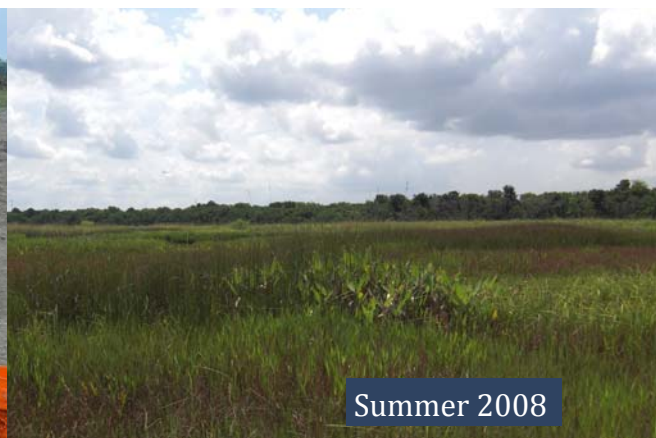
Fall 2003

Wetland Restoration Team working with Eagle Scout Troop 505 to restore coastal prairie wetlands in Phase I, which is completely vegetated after 5 years.
