BIOENGINEERING FOR COASTAL BANK STABILIZATION: CASE STUDIES

Lee Wieshar and Leslie Fields, Woods Hole Group, Falmouth, MA

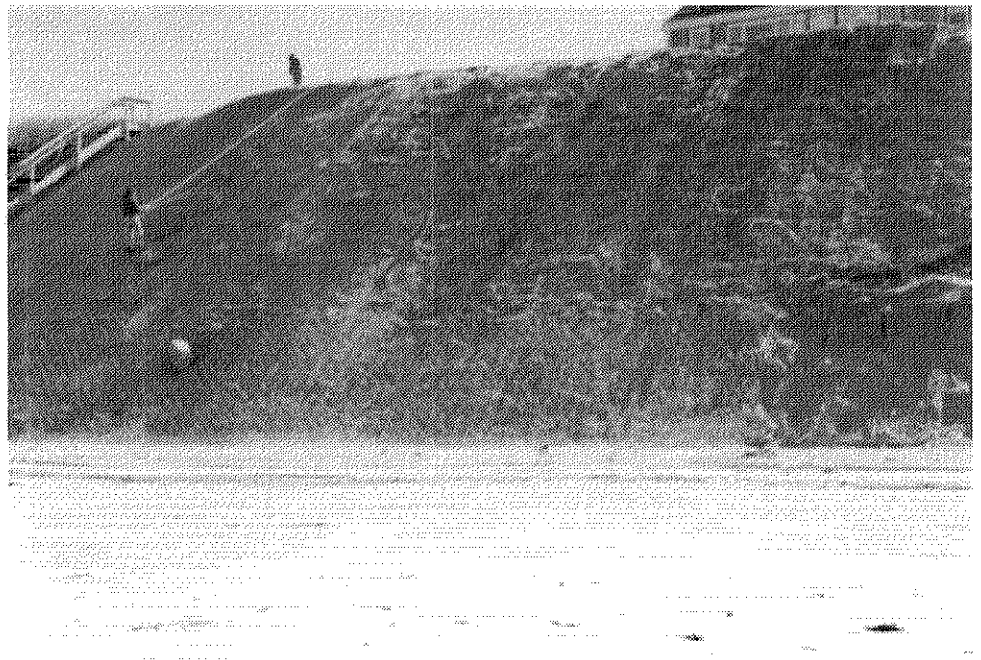
Fig 28. Coastal bank with fill and jute netting being planted

nel in harnesses and climbing gear (Figure 28). The climbing ropes were fastened to stakes driven into the ground. These stakes were iron bars driven into the ground about ten feet. The planters had to rope down the bank face. Then they went over, walked up the stairs, and roped down again. They're planting beach grass here, and they're also planting *Rosa Rugosa*, which we suggested shouldn't be done in the first year because of the steep bank slope. However, the client basically said, my wife likes roses, I'm your boss, and I want roses. So we planted roses.

The next step was installing jute netting. We put jute net all the way across the face of the bank. All during this process the neighbors were all terribly intrigued about what was going on and wondering what was going to happen next, and when we put all this net across the face, they were wondering what was going to happen.

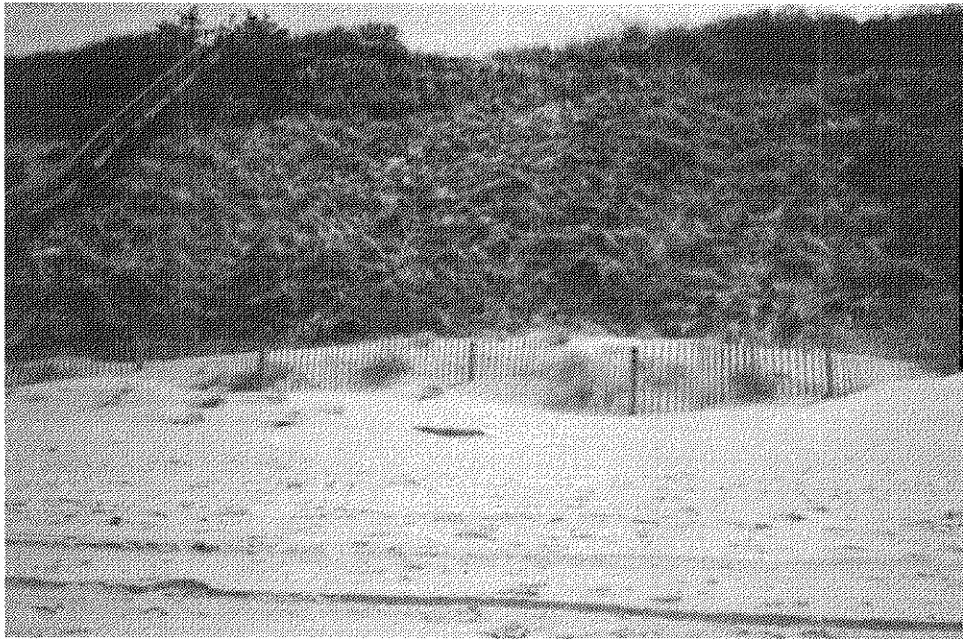
Fig 29. Completed bank stabilization project

This is about a year and a half after it was done. This is what it looked like in March (Figure 29). Now, I have to be quite honest with you. Even though it looks fairly fine here, we're going back after next month for the first time for maintenance since 1993. There's about a two foot, two and a half foot erosion scarp here, we're going back just to fix the toe. But that's a pretty good success considering the fact that the construction was completed in 1993, and we've had no problems since then.

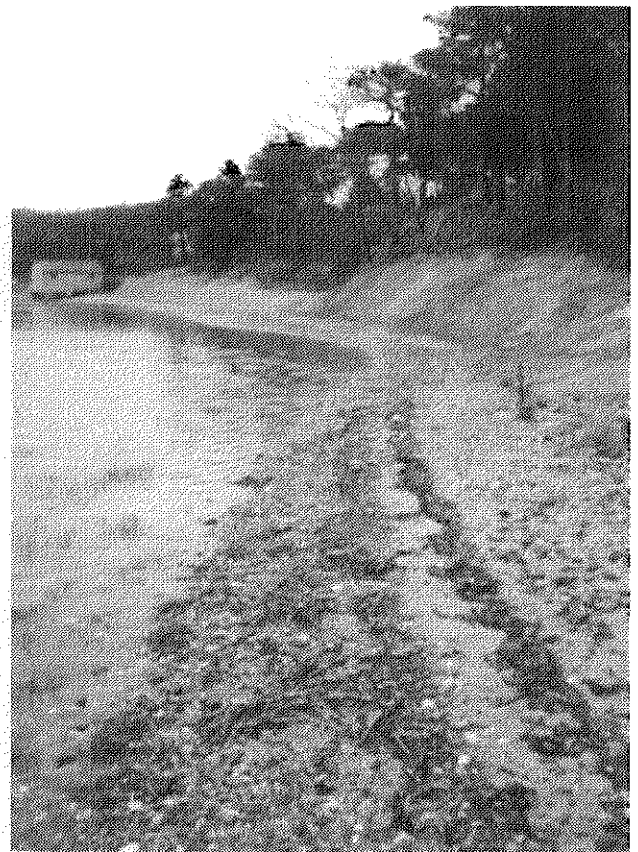
Fig 34. Bournes Pond bank stabilization project completed

And here's what it looks like now, planted with the jute netting on top (Figure 34). This was done last season, so it's really only been in for about four or five months.

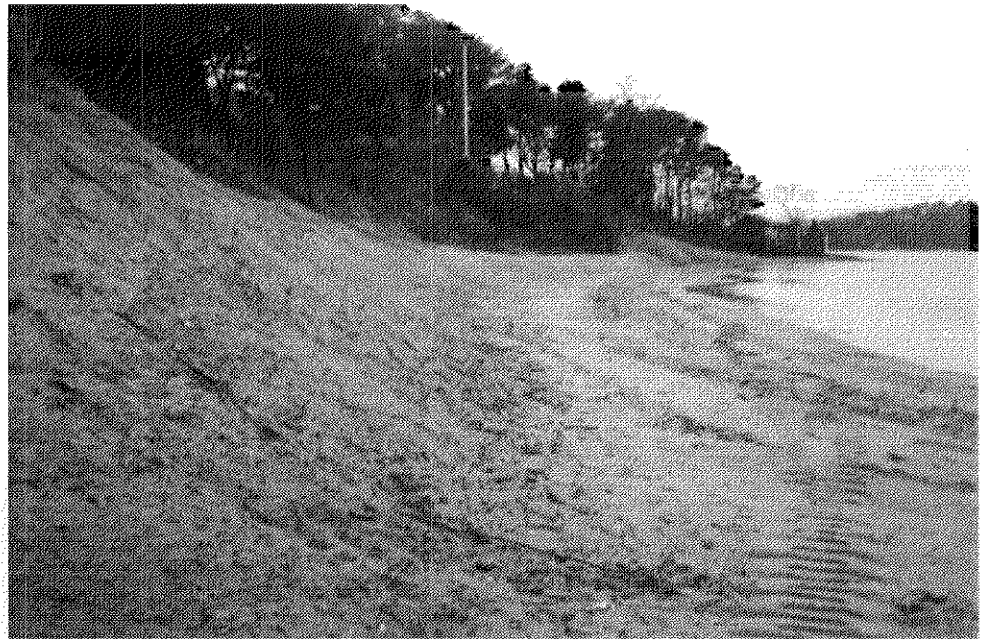
Fig 35. Fiber rolls covered with sediment

This is an example of how fiber rolls can be covered with sediment (Figure 35). Again, another Anchor Marine project. You really wouldn't even know that they were there in this case.

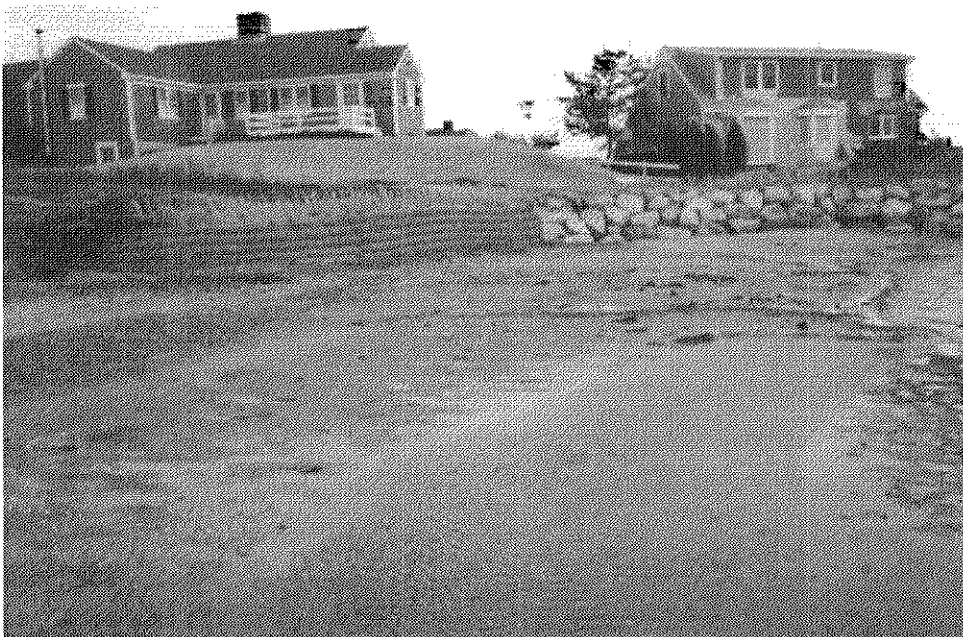
Fig 36. Using fiber rolls to construct a return

And here's a very good example of how they dealt with a return using fiber rolls (Figure 36). We still have to worry about end effects at the end of these soft structures. So they brought the fiber rolls around the end of the natural bank to minimize any sort of end effect erosion. And I thought this was a very nice treatment of that.

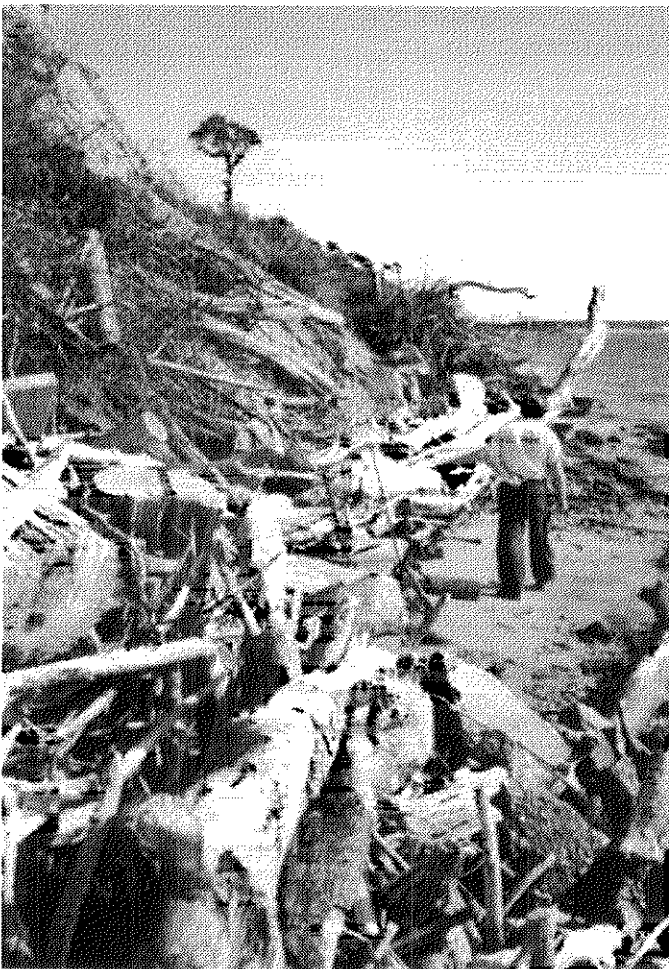
I'm going to close with the next two slides. Again, this guy owns a game preserve. He's got lots of trees, woods, woodlands, so his solution before we came to the project was to put dead wood down here. And there are massive piles of dead wood at the base of this bank — massive. And ordinarily we'd encourage him against doing this now, but right now we've recommended

Remember, we've got two miles or more of shoreline, so that's fine for this little stretch here. And this is from the ground, an example of what all that dead wood looks like there (Figure 39).

Fig 39. Dead wood dumped at bank toe to dampen wave energy

just to leave them there because they are so dense that they're actually being effective. But I wouldn't recommend that people go out and do that in the future. For now, we're just going to leave it.
